**PHASE I
ENVIRONMENTAL SITE ASSESSMENT**

**Speous IR#8,
Lower Nicola Indian Band
Merritt, British Columbia**

Project No: 10-0374
April, 2011

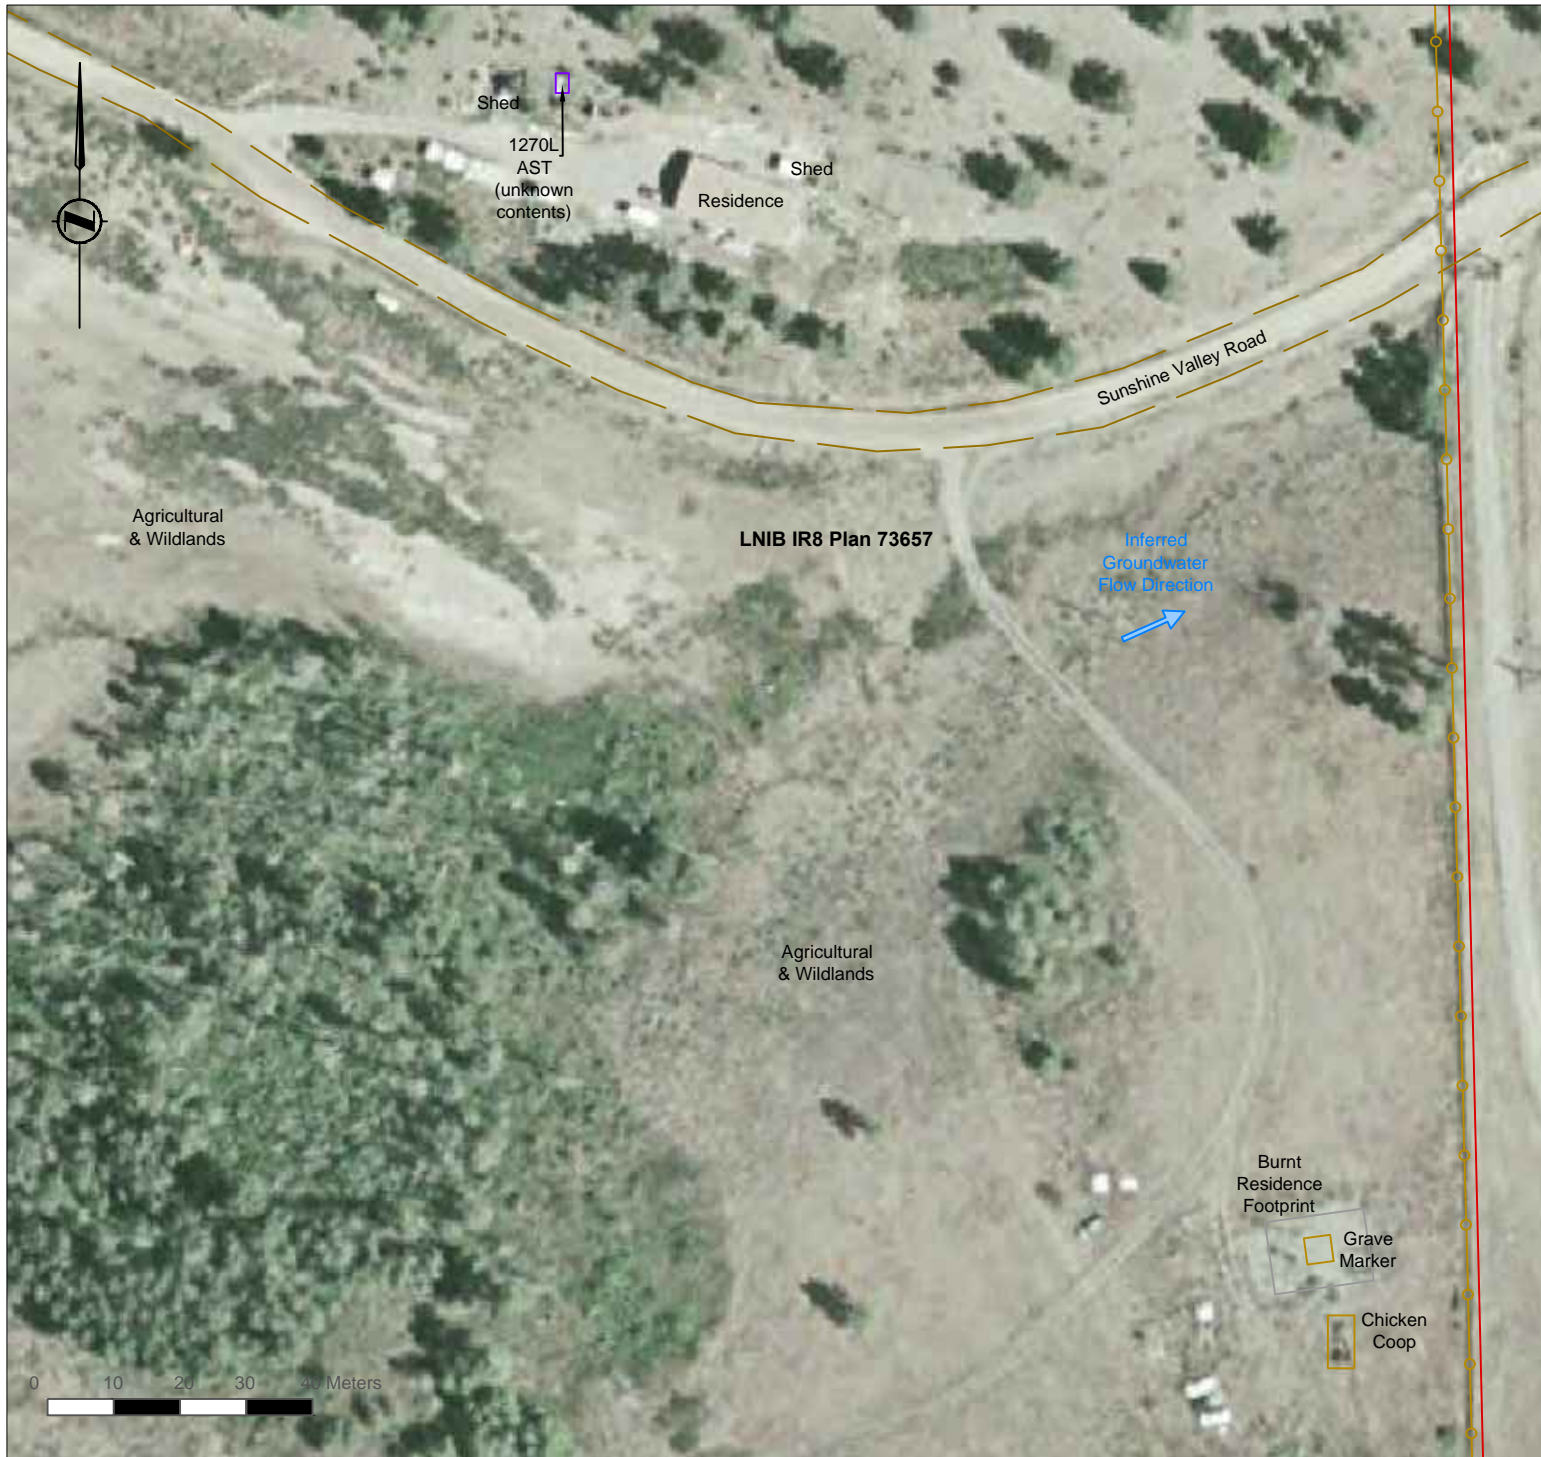
LNIB / INAC
Phase I
Environmental Site Assessment
Speous IR #8

- AST
- FENCE
- - - GRAVEL ROAD
- RESERVE BOUNDARY
- ↗ SURFACE / GROUNDWATER FLOW DIRECTION

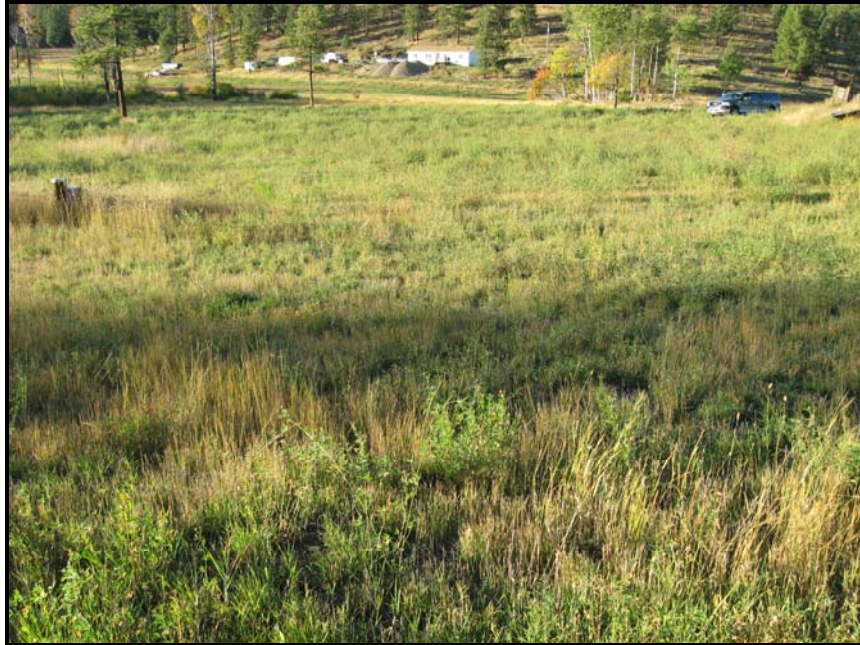
Photo 1. Overview of Speous IR #8 facing northwest. Note the only residence on the reserve and open field occasionally used as a pasture.

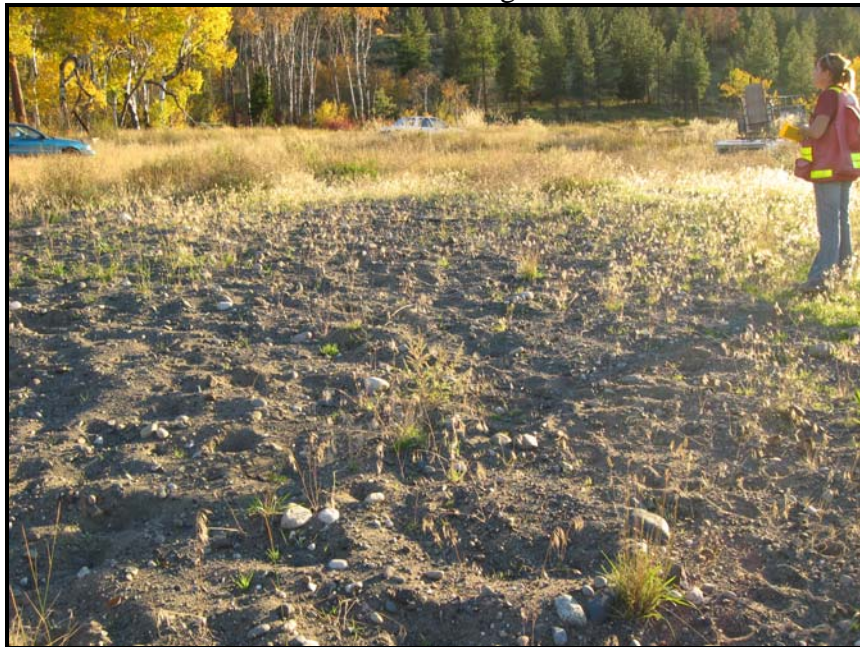
Photo 2. Overview of former house location facing southwest.

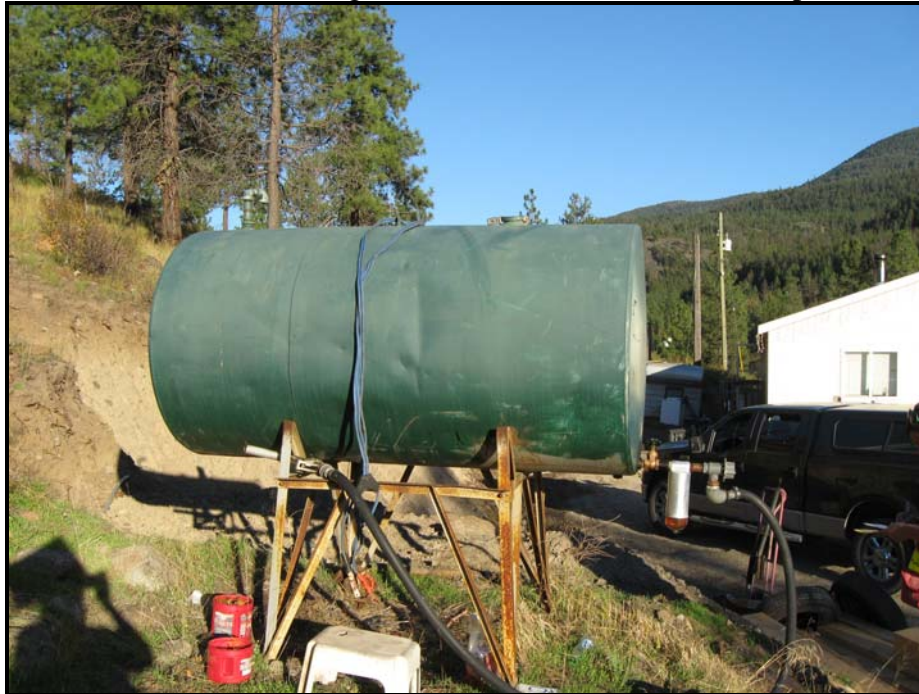
#	Location (Site ID)	Capacity	Contents	Active	Condition
1	AST-Speous IR#8	1 x 1270L	Unknown	Yes	One active AST west of the house. AST appears in fair condition. Some rust on the tank and weeping at the bung and hose. No secondary containment. 0.8m diameter soil staining below.

Minor stains associated with the use and handling of petroleum hydrocarbons were noted below the AST located at the current residence on Sunshine Valley road. This “spotty” soil stain was 0.8m in diameter, and appeared surficial.

Photo 4. View of 1270L AST facing east at the current residence on Speous IR#8.

During the site visit, one AST was noted at the current residence. The AST appears in acceptable condition, however there is no secondary containment and limited spotty soil staining was noted below. The AST is retained as an APEC with details summarized in the table below.

A Phase 2 ESA is recommended to determine the presence or absence of contaminated media at APEC 1 identified by this assessment. No other concerns were identified on this reserve at this time.
